# Peat slope failures and other mass movements in western Ireland, August 2008

A.P. Dykes<sup>1,\*</sup> & P. Jennings<sup>2</sup>

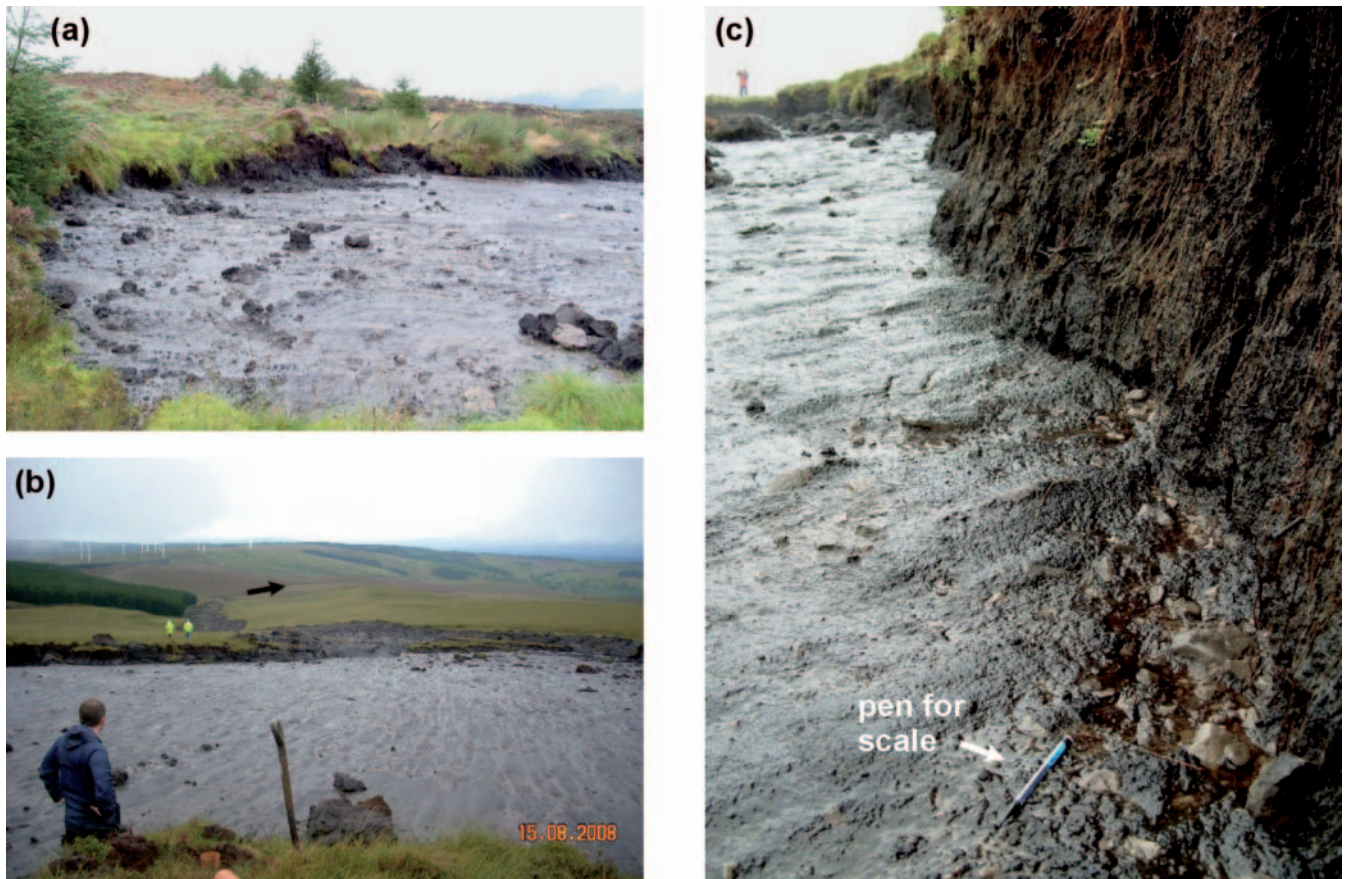
This peat slide (Fig. 2a) was located above the western side of a mountain track adjacent to a small area of forestry ( $54^{\circ}09.00'N$ ,  $08^{\circ}11.8'W$ ; 320 m altitude). It occurred around a natural drainage line near the head of a small tributary stream where surface and subsurface runoff converge, which is a common scenario for such peat failures (Warburton *et al.* 2004). The slope in this area was mantled with around 0.8 m deep blanket peat overlying a mineral substrate that may have comprised *in situ* weathered material.

This peat slide ( $54^{\circ}08.00'N$ ,  $08^{\circ}09.9'W$ ) occurred immediately NW of the Tullvnhaw Windfarm, on the summit of Corry Mountain, at an altitude of 405 m (Fig. 2b). The failure site was characterized by blanket peat up to 1.4 m deep overlying *in situ* weathered rock and/or till. Sub-horizontal seepage lines were visible as a plane of separation at the peat–mineral interface where shear failure occurred (Fig. 2c). These seepage lines resemble those recorded in many of the Dooncarton Mountain

and Shetland Island landslides in 2003 (Moore *et al.* 2006; Dykes & Warburton 2007a, 2008b). This slide generated a flow of peat debris that entered a tributary stream course and was carried northwards an unknown distance towards the Owengar River.

**Fig. 2.** (a) Head of Landslide 1. (b) View down Landslide 2 showing the debris runoff extending into the head of a tributary stream. (c) Close-up of the failure surface at the peat–mineral interface in the head margin of Landslide 2. All photographs dated 15 August 2008.

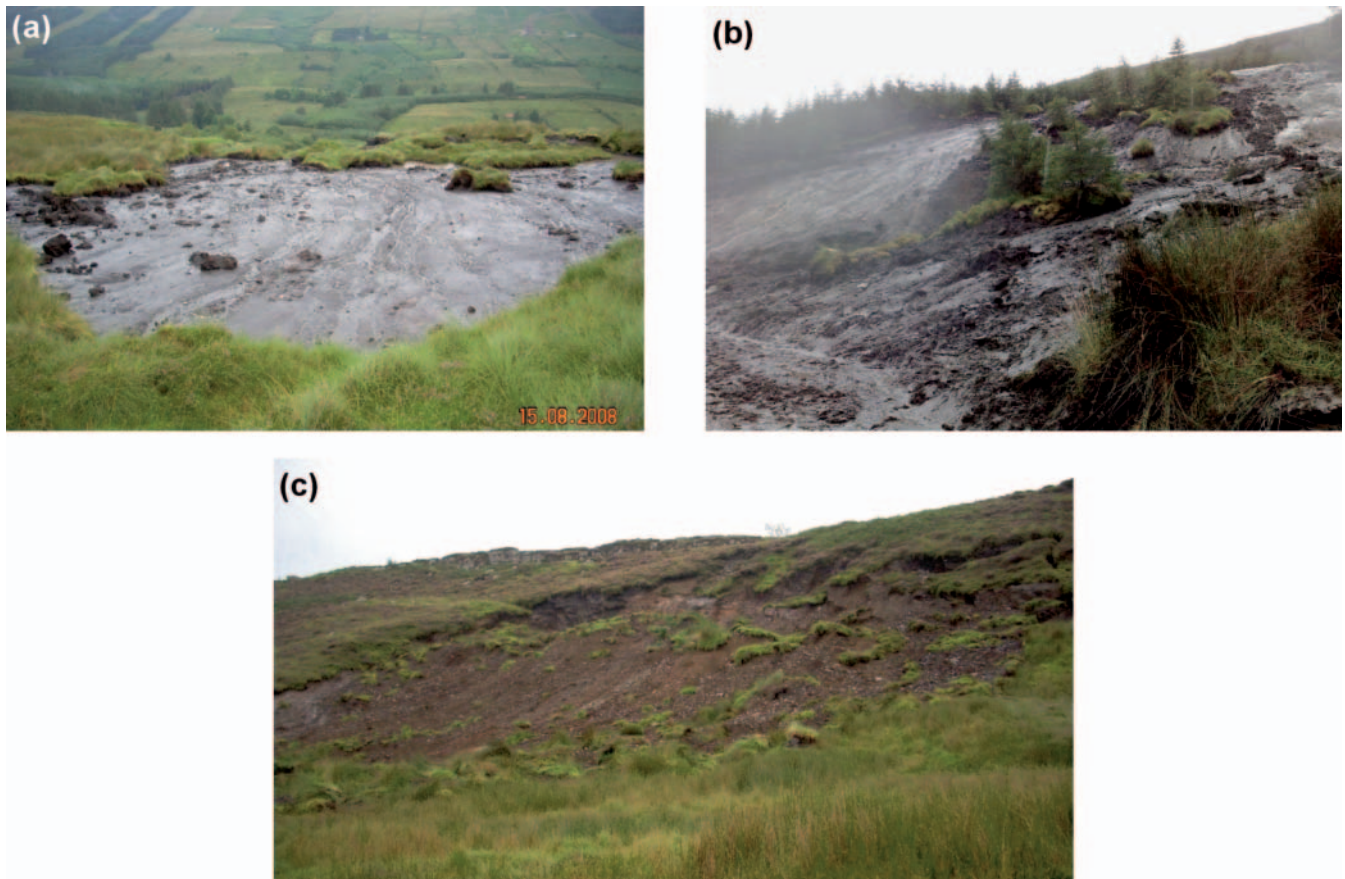
The main cluster of peat and soil landslides originated upslope of the Arigna to Glen road (around  $54^{\circ}06.3'N$ ,  $08^{\circ}11.0'W$ ) at altitudes of 300–350 m. Five landslides occurred within a distance of *c.* 500 m along the slope. These landslides blocked the road from Glen to Arigna that trapped the elderly resident in his home. Landslides 3 and 4, both peaty-debris slides, occurred above a sharp convex break of slope above the road (Fig. 3a and b) on a hillslope with blanket peat cover 0.4–0.6 m deep over a thin (up to 0.2 m) mineral soil horizon overlying rock. Both slides were associated with visible drainage lines upslope of the failure heads, and natural subsurface pipes and seepage lines were observed feeding water into the failures at the depth of the shear surface (i.e. at the base of the thin soil layer beneath the peat). Landslide 5 was similar to Landslides 3 and 4 in its slope and hydrological contexts but involved much less peat (<0.5 m depth) over the failed soil horizon, and exposed bedrock in the head of the failure revealed a small flowing spring that undoubtedly contributed to the generation of excess water pressures that triggered this

failure. Landslides 6 and 7 were different in character, involving deeper rotational failure of glacial or colluvial debris on a steep scarp slope between the road and the summit plateau (Fig. 3c). Landslide 7 had not fully developed, being characterized only by a major tension crack 0.1–0.2 m wide at the surface, but the context is the same as that of Landslide 6 so a similar failure scenario can be reasonably inferred.

**Fig. 3.** (a) View down Landslide 3, above the convex break of slope. (b) Peat and soil debris from Landslide 4 descending to the road. (c) Landslide 6 on the scarp slope above the road. All photographs dated 15 August 2008.

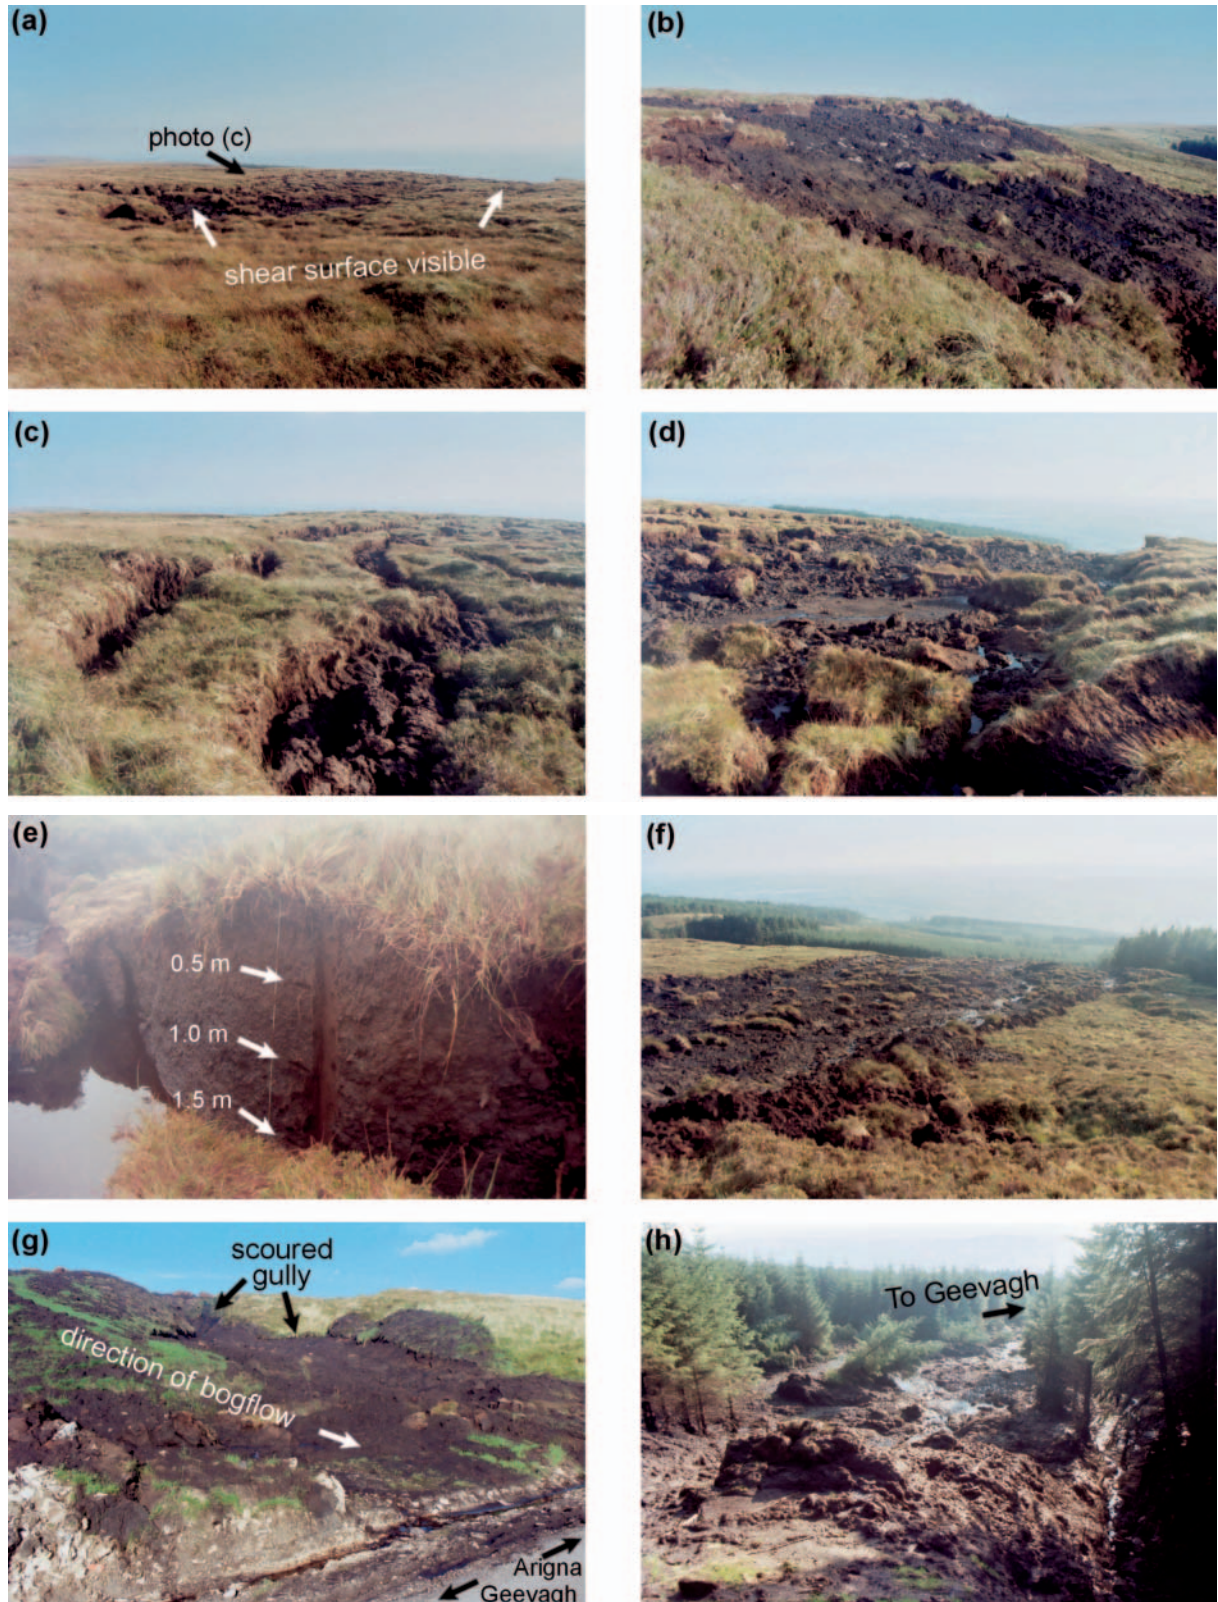
The landslide originated on the summit ridge of Carrane Hill in Straduff Townland at 54°07.2'N, 08°13.0'W, at an altitude of 400 m (Fig. 4a). This ridge

constitutes a gently sloping ‘plateau’ bounded by steep escarpments along either side (Fig. 4b), though containing subtle topographic variations. Large bogflows have occurred as a result of failure of the peat at the escarpment crest on the southern side of this plateau in 1945, 1984 and around late 1990–early 1991 (Alexander *et al.* 1986; Yang & Dykes 2006; Dykes 2008a). The latest failure involved the intact blanket peat between the 1945 and c. 1990 bogflows. Slope gradients and failure morphologies are shown in Figure 5. Although the lateral margins of the source area clearly show that lower catotelm peat flowed out from beneath the stronger, more fibrous acrotelm peat (the latter remaining as large, intact but subsided rafts as observed in all bogflows) (Fig. 4c), a shear surface within the basal peat at least 20 mm above the peat–mineral interface was exposed in the steeper head zone, with a small patch of shear surface also visible on the steeper slope near the escarpment edge (Fig. 4d). Shearing in the lower catotelm is a defining characteristic of bog slides, which tend to occur on slightly steeper slopes than bogflows (Dykes & Warburton 2007b). Boylan *et al.* (2008) hypothesized that all types of peat failure begin with this type of basal shearing, but morphological evidence from other sites suggests an alternative hypothesis for bogflows and bog

The peat was typically 2.5 m deep (varying between 1.8 and >3 m) (Fig. 4e), giving a failure volume of 35 000 m<sup>3</sup>. However, following the failure, 1.0–1.5 m of semi-liquid peat slurry remained across much of the source area, with 0.8–1.2 m thick rafts of acrotelm peat floating in the slurry, typically 60% submerged with 0.3–0.5 m visible above the slurry surface. This means that *c.* 20 000 m<sup>3</sup> of (semi-liquid) peat was lost from the source area and moved down the escarpment slope towards and across the road (Fig. 4f and g), the mobility of the flow probably greatly enhanced by additional water from the heavy rain and associated surface runoff. Below the road (Fig. 4h) the flow followed the same stream channel for 4.5 km to the Geevagh sports field as in 1984 (Alexander *et al.* 1986). Interestingly, there is no report of a similar downstream inundation associated with the *c.* 1990 bogflow. Whereas this earlier, slightly smaller flow also crossed the road, it had first passed through an area of densely planted forest, which would have retarded the momentum of the flow as well as trapping peat debris above and between trees on the slope.

**Fig. 4.** Landslide 8 (SDF-08) on 20 September 2008 unless otherwise indicated. (a) View from above the head showing the whole landslide above the edge of the plateau. (b) The escarpment, the large peat rafts in the centre indicating the approximate downslope limit of peat failure. (c) The eastern margin showing displaced intact rafts of peat, each subsided by 0.5 m relative to the adjacent outer raft as a result of outflow of (semi-)liquid catotelm peat. (d) The lower 6° segment of the source area showing evidence of a shear surface within the basal peat. (e) The only accessible *in situ* undisturbed peat profile, from which samples were extracted, seen here in thick fog immediately prior to sampling on 19 September 2003. (f) The runout crossed a topographic bench below the escarpment, then flowed down the steep slope alongside the forest for 150 m before (g) pouring onto and across the road and (h) down through the forest below the road where it eventually fed into the stream that descends to Geevagh.

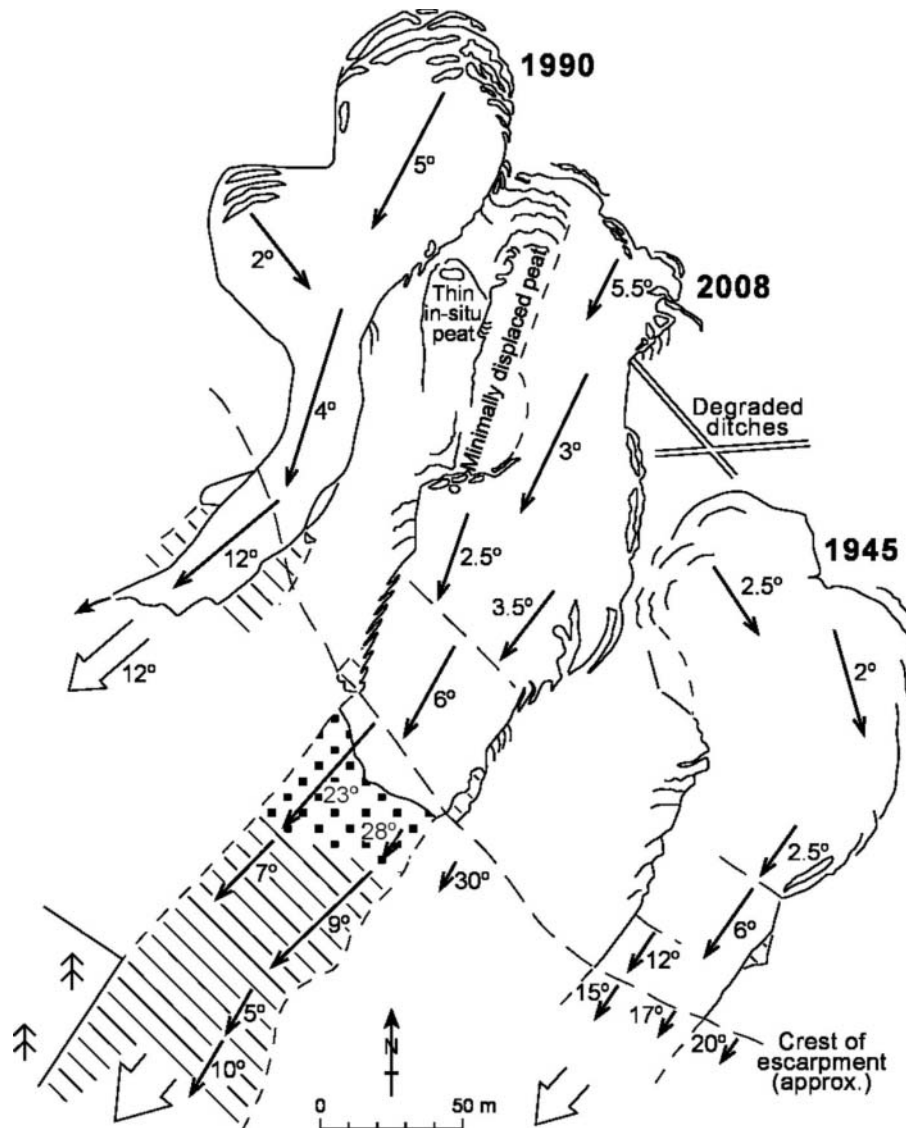
**Fig. 5.** Geomorphological map of landslide SDF-08 as surveyed on 19 September 2008, showing its location exactly between the *c.* 1990 bogflow (reference SDF-90) to the NW and the 1945 bogflow (SDF-45) to the SE. The outer extents of the respective source areas are mapped, with some interior details indicated. Coarse stipple indicates *in situ* peat or soil overridden by the flow; diagonal hatching indicates peat slurry and debris deposited on intact ground. Measured gradients are shown. The apparent northwards bias of source area development reflects the gently rising elevation of the ridgetop plateau in that general direction. The presence of the earlier bogflows, and another much larger one nearby, indicated an inherent instability of the blanket bog above this escarpment. The 2008 failure was therefore unsurprising, but the fact that it occurred precisely between the two older source areas without disturbing either of them was unexpected.

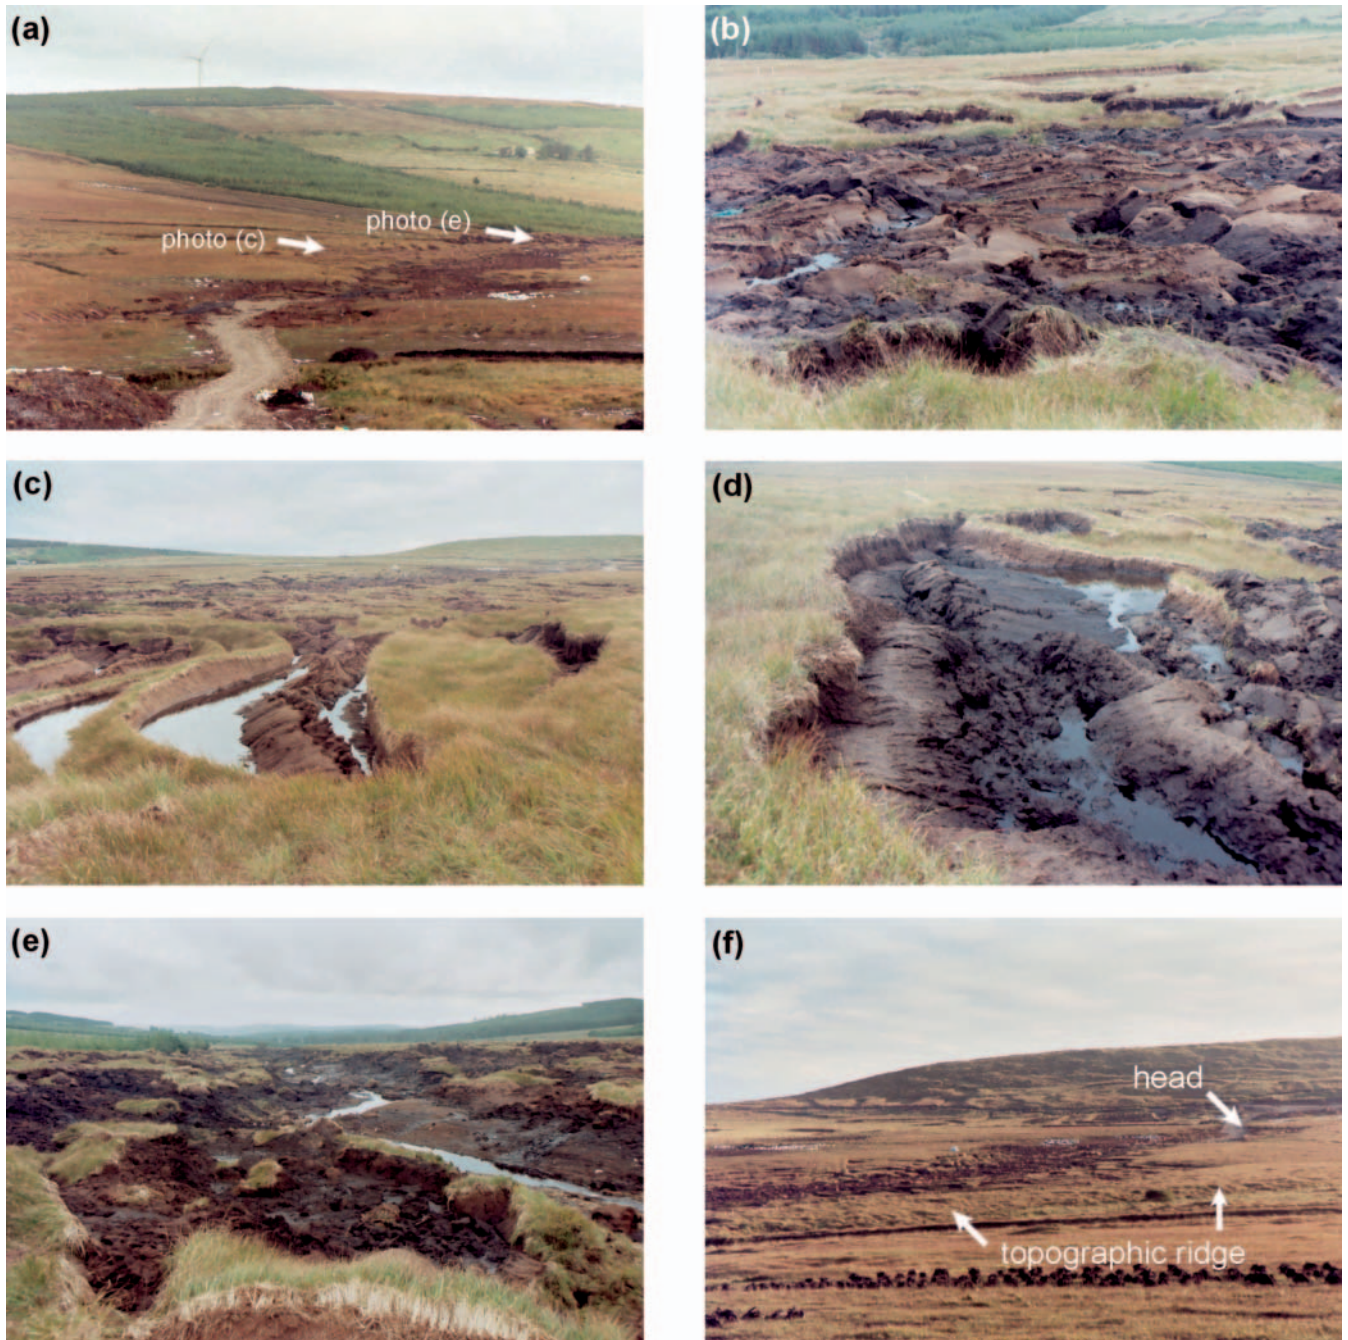
catotelm peat retrogressed outwards from the main flow, causing subsidence and separation of the acrotelm layer along the tines (Fig. 6c). This retrogression appears to have occurred in a similar manner to naturally occurring bogflows (Fig. 6d, compare Fig. 4c).

At the foot of the affected slope is a stream channel in the bottom of a small 'valley' around 3 m deep and 15–20 m wide (Fig. 6e). Adjacent and parallel to this valley on the side of the failure is a slight ridge of probably slightly drier and firmer peat (Fig. 6f), similar to conditions found near the edges of escarpments or other convex breaks of slope (e.g. Mitchell 1935; Tomlinson 1981; Alexander *et al.* 1986). This ridge may have caused failed peat to overflow the eastern margin to

**Fig. 6.** Landslide BHW-08 on 16–17 September 2008. (a) View down the peat flow from above the head. The dark course of the main flow is clear, but much of the failed peat extends some distance beyond this zone. (b) View across the main flow approximately halfway along the failure showing some acrotelm blocks chaotically mixed with fully disrupted catotelm peat. (c) The western margin showing a displaced intact raft of peat subsided by 0.5 m relative to the adjacent *in situ* peat, and displaced strips of acrotelm peat defined by tine cuts and dragged downslope by the outward flow of (semi-)liquid catotelm peat. (d) Catotelm peat squeezed upwards by rotation and sinking of a failing strip of acrotelm peat (compare Fig. 4c). (e) View downstream across the toe of the landslide (right). (f) The upper half of the landslide seen from the opposite side of the ‘valley’, showing the slight ridge of peat across the slope adjacent to the stream.

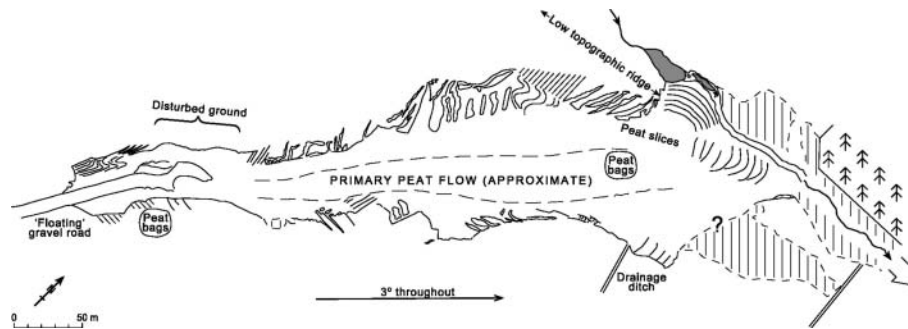
create the 0.25 ha deposit on *in situ* peat (Fig. 7). Failure of this ridge allowed peat debris to enter the stream valley, temporarily blocking the stream and diverting the flow of peat slurry and debris downstream. The total volume of failed peat was 130 000 m<sup>3</sup>, of which possibly as much as 40 000 m<sup>3</sup> was lost from the failure site and formed the damaging flow that extended down the length of the Glashoreag River (*c.* 6 km along the valley) and sent peat fines onward into the Smearlagh River and, subsequently, the Feale River.

**Fig. 7.** Geomorphological map of landslide BHW-08 as surveyed on 16 September 2008. The road had been partially rebuilt to allow recovery of machinery from the peat flow. Broad vertical hatching indicates peat debris deposited on intact ground (i.e. undisturbed peat). Narrow parallel diagonal lines indicate (schematically) tine cuts in the peat showing minimal displacement. Curved parallel lines indicate displaced strips of acrotelm peat that separated along tine cuts. All markings indicate the outermost extent of visible disturbance of the peat. 'Peat bags' are white plastic sacks filled with cut and dried peat awaiting collection. Some of the bags that had been lying on the ground near the 'floating' road were moved 350 m downslope by the main flow of the failed peat. Grey shading indicates ponded stream water.
