STABILITY OF MAN MADE GLACIAL TILL SLOPES IN SOUTHWEST IRELAND

K.Gavin¹, J.F. Xue¹ and P.Jennings²

¹*Department of Civil Engineering, University College Dublin, Ireland*

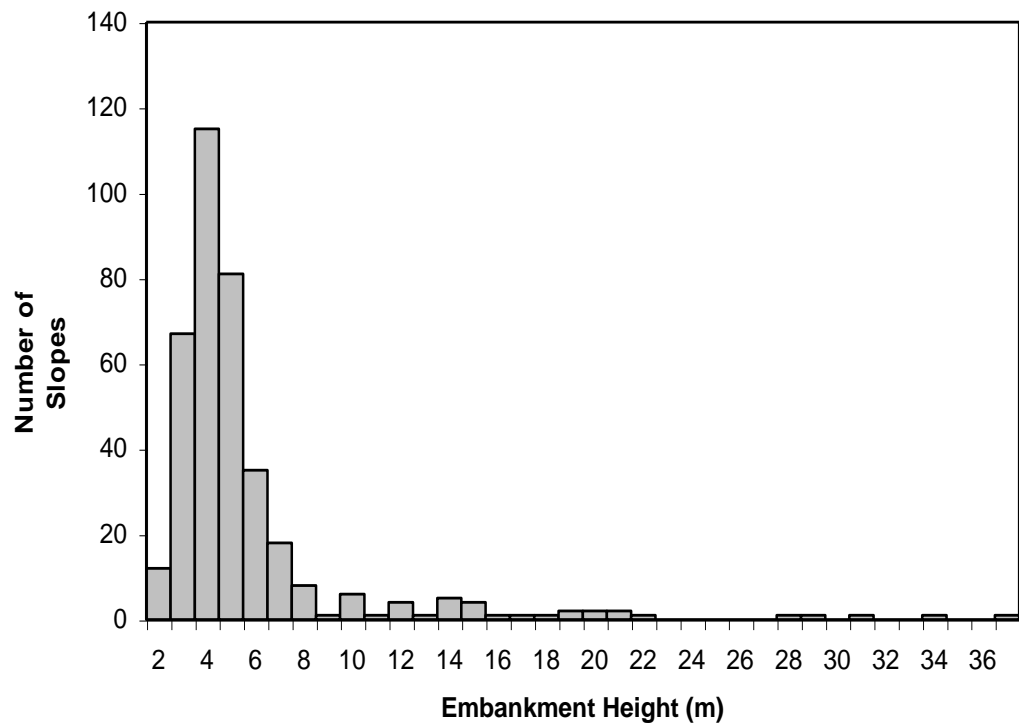
(a) Range of Embankment Height

The survey showed that embankments ranged in height from 3 to 30m, with a typical height of just under 5m (Figure 2a). The slope angle of embankments lay in the range 24 to 60 degrees, with 90% of slopes having a slope angle above 30 degrees (Figure 2b). Statistical data regarding the slope height and angles of cutting slopes reveals that slope angles adopted for construction of embankments and cuttings are remarkably similar.

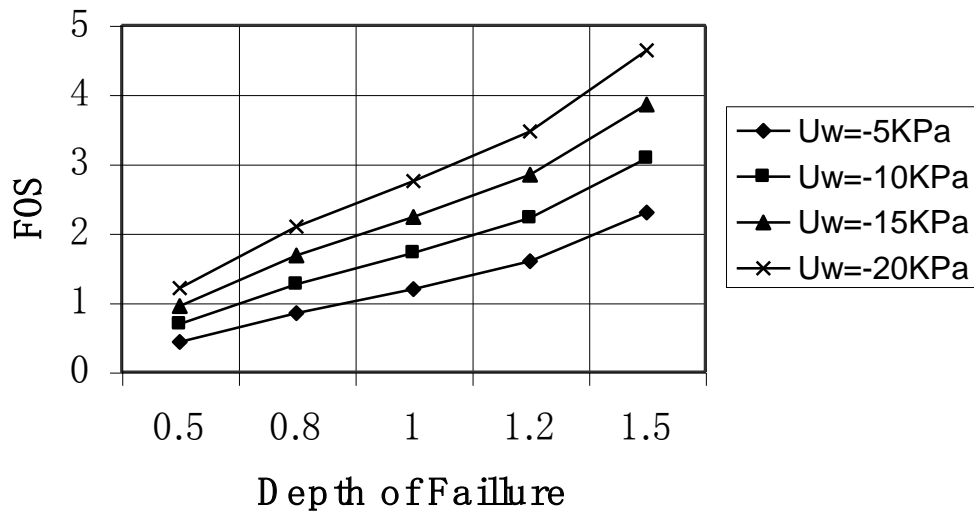
Figure 5. Effect of Suction on the stability of the embankment at Oola Bank

The effect of suction on the stability of the slope at Oola bank can be considered by inserting a range of negative values of u_w into equation 6. The following soil parameters were used in the analysis, $c' = 0$, $\gamma = 20 \text{ kNm}^3$, $\beta = 45^\circ$, $\phi'_{cv} = 34^\circ$ and u_w was varied from 0 (no suction) to a maximum of -20 kPa , which are typical of the range of measured negative pore pressures in this material. The highest uncertainty relates to the choice of a representative ϕ^b value. To date there is no experimental work to quantify this parameter for Irish soils. Gan et al. (1988) (ref no.??) report tests on a glacial till, which indicate ϕ^b varies from 7° at high suctions to 25.5° at low suction (0 to 50 kPa). A ϕ^b of 20° was adopted in the analysis.

The results of the analysis assuming constant negative pore water pressure in the failed mass are plotted in Figure 5 as the variation in FoS against the depth of the assumed failure surface. The figure suggests that a planar failure surface ($FoS < 1$) would develop at a depth of 1m at Oola Bank if suctions in the near surface region of

the embankment fell to a level of -5kPa . This figure is compatible with quoted residual negative porewater pressures measured in other coarse grained soils.
