Performance of 150 year-old railway slopes in glacial till: case study from southwest Ireland

Paul Jennings

Applied Ground Engineering Consultants Ltd., Bagenalstown, Carlow, Co. Carlow, Ireland: pjennings@agec.ie

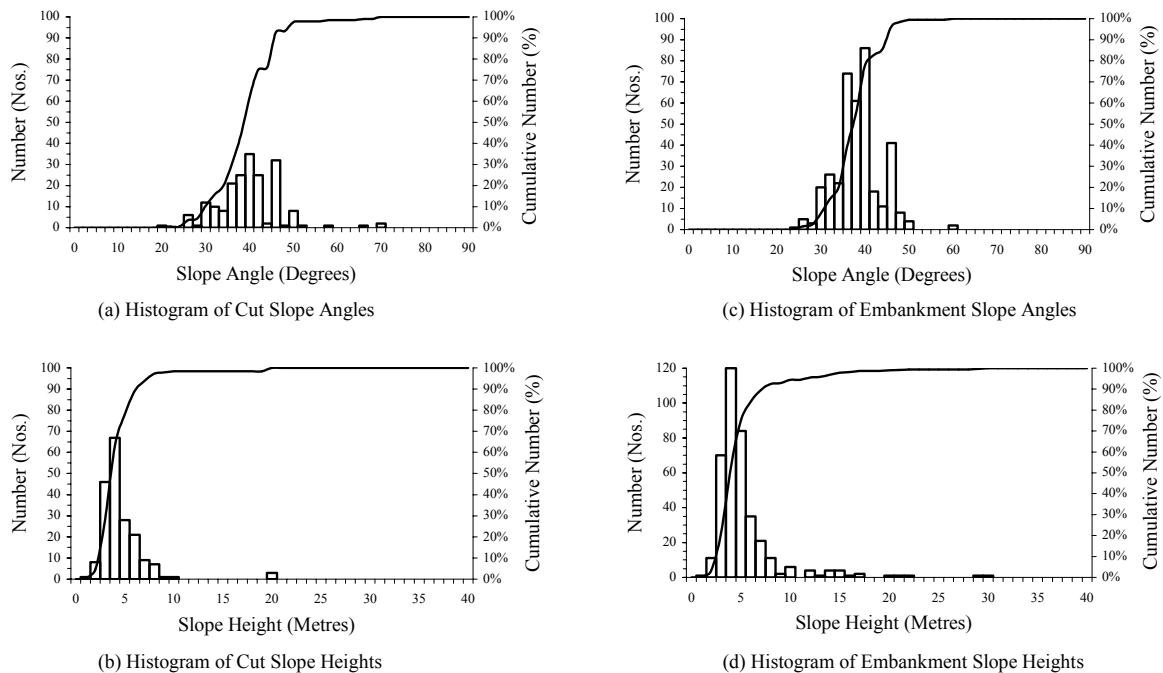
Figure 1: Histograms of Slope Angles and Heights

angles. About 90% of all cut slopes are at a slope angle greater than 30° . A summary of soil cutting angles and heights is shown in Figure 1(a and b).

Embankments ranged in height from about 3 m to 8 m but were generally less than 5 m in height. Embankment side slope angles ranged from about 30° to 45° . About 92% of all embankments are steeper than 30° . Few embankments are steeper than 45° . A summary of embankment slope angles and heights is shown in Figure 1(c and d).

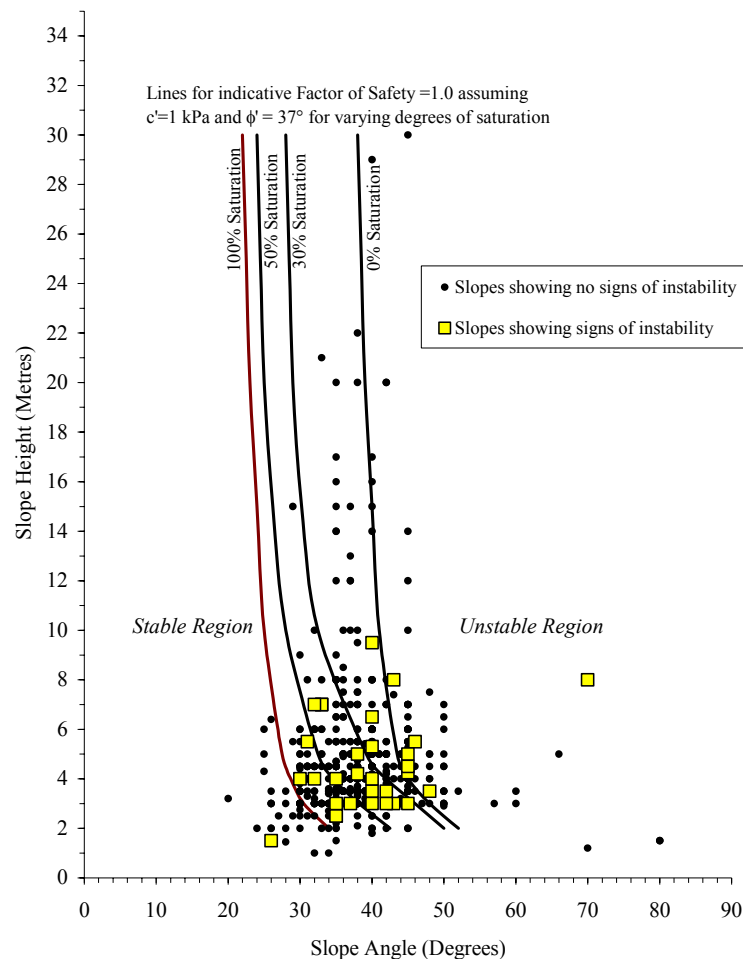
Figure 2: Slope Angle versus Slope Height

Figure 2 shows a plot of slope angle versus slope height. Superimposed on the figure are the indicative Factor of Safety (FoS) = 1.0 lines generated from the generalised soil strength parameters ($\phi' = 38^\circ$ and $c' = 1$ kPa) for varying degrees of saturation. Where 0% saturation represents no groundwater within slope and 100% saturation represents groundwater surface coincident with slope surface.

Slopes showing signs of instability should be concentrated to the right of the FoS=1.0 lines, this is not the case. Unstable slopes show no correlation with either slope angle or height. One possible explanation for the lack of any correlation of failures is the heterogeneity of material within cuttings and the likely presence of site-specific destabilising factors. Using the generalised soil strength, a notable proportion of all slopes have an indicative FoS less than 1.0, even where there is no groundwater in the slope.

(6) Whilst the general findings indicate that glacial till is a relatively robust material, till is heterogeneous in nature and pre-existing localised instability problems, particularly in cuttings, may be present. This likely explains the higher proportion of instability in cut slopes compared to embankments and the generally random pattern of failure with respect to slope angle and slope height (see Figure 2).
