Title of paper: Analysis of the peat slide at Pollatomish, County Mayo, Ireland

Names of authors: Michael Long and Paul Jennings

Abstract: A major landslide event occurred at Pollatomish, County Mayo, Ireland in September 2003, during a period of intense rainfall. It comprised about 30 significant individual longitudinal planar type slides of peat and weathered rock. Relatively simple limit state stability analyses, using the method of slices and an infinite slope analysis, were used to model the slide and it was found that the features observed on site could easily be reproduced. These included confirmation that thin layers of peat could be stable on steep slopes but the margin of safety reduces rapidly under elevated pore pressure conditions. As was observed in the field, the analyses suggested the most vulnerable zone was the upper layer of weathered rock but that slides could occur in the peat if its thickness was appreciable. Careful site characterization is vital in such studies. Here efforts have been made to understand the effect of fibres on the peat strength and some sensitivity analyses have been performed to assess the critical engineering parameters of the peat.

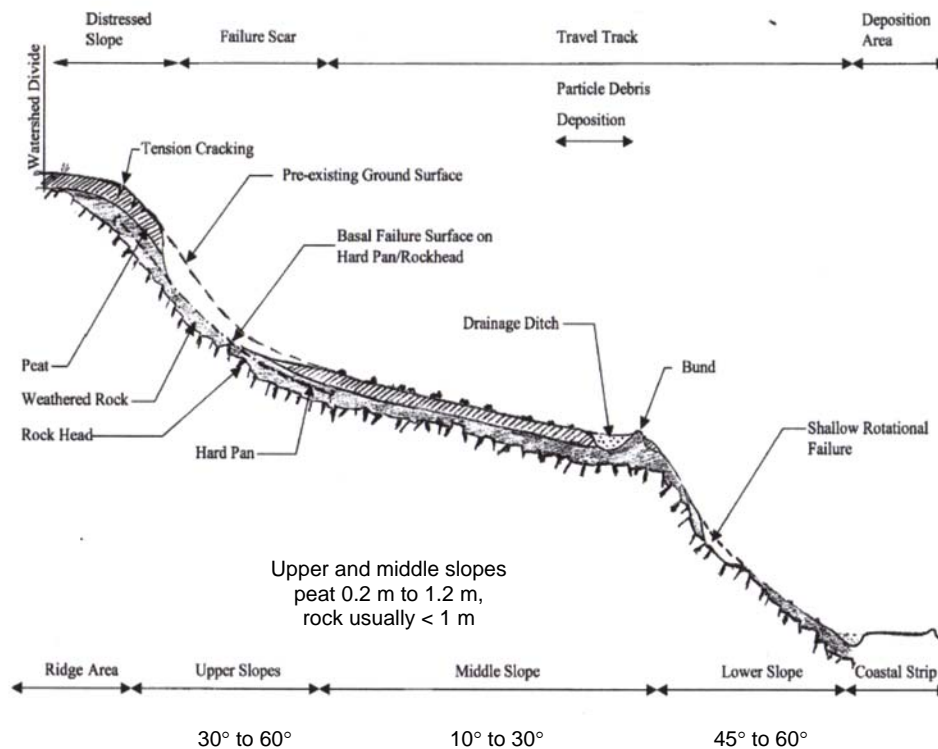
Figure 2. Schematic section through slope (adapted from Tobin 2003)

The slope profile (applies generally but particularly to the north and east facing hills) comprises some or all of the following elements, as shown on Figure 2:

- Ridge line.
- Upper slope. This is the zone generally above the 150 m contour and comprises a steep upper slope with inclination 30° to 60° . It may represent an old corrie back-wall where there has been accentuated erosion by ice during the last Ice Age.
- Middle slope. Relatively smooth slope of 10° to 30° between the 50 m and 150 m contours.
- Lower slope. Towards the coastal lowlands the slope increases to approximately 45° to 60° . It has a benched rather than smooth appearance
- Coastal strip. This consists of a narrow strip of moderately sloping ground varying from 10° to 30° .

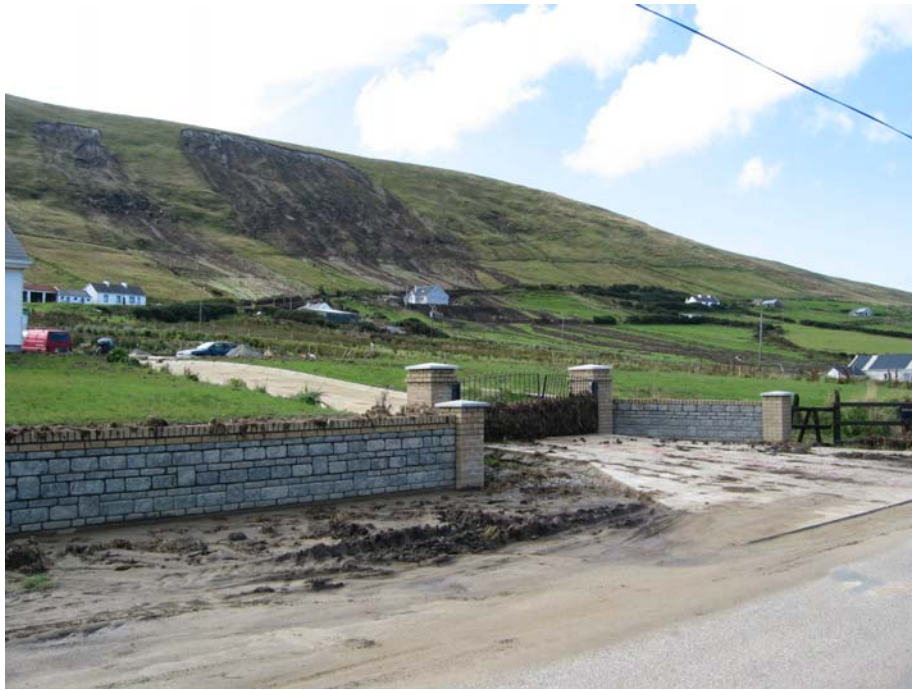
Figure 3. General view of slips on north side of Dooncarton Mountain facing towards the west. Type A failures mostly in upper slopes. Type B failure near middle house. Note movement arrested by drainage ditch at base of middle slope. Debris flow into lower slope cause by water flow.

Type A failures are located on the upper slope and are the dominant failure type (Figures 3 and 4). Apparent failure scars on the lower slopes, for example behind the cemetery at Pollatomish, are primarily as a result of landslide debris passing over the existing ground surface. The ground in these areas did not fail, though it was scoured by the passage of debris and subsequent erosion by surface water. Once mobile the soil material mixed with rain and groundwater and behaved as a fluid. Down slope flow was mainly via the existing drainage channel and small topographical features.

The authors have identified about 50 distinct failure zones, about 30 of which are of significant (of more than a few metres width) size. Some of these coalesce to form larger failure masses. Some typical failures are shown on Figure 3. Note that the transverse drainage ditch absorbed a significant fraction of the slide energy and protected the privately owned land down slope. Figure 4 shows a detail of a failure on the upper and middle slopes. Scar widths varied between a few metres to in excess of 150 m and involved volumes of material up to 20000 m³. The total volume of material involved is estimated to be in the region of 200,000 m³.

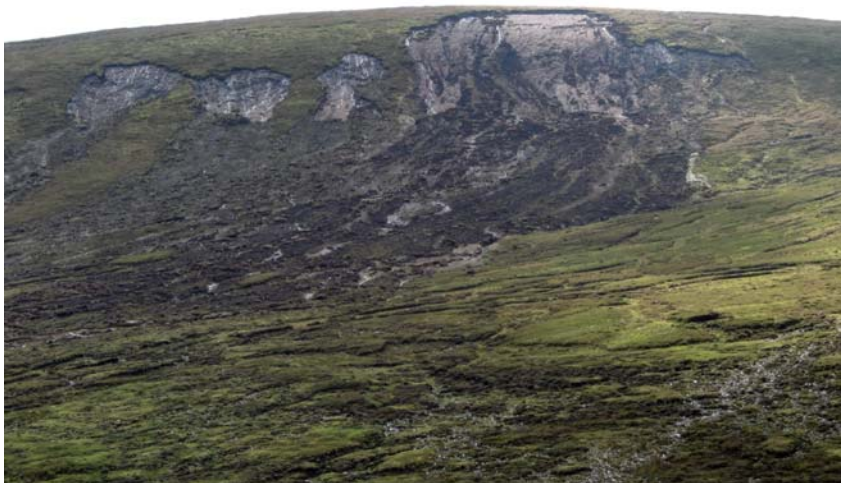
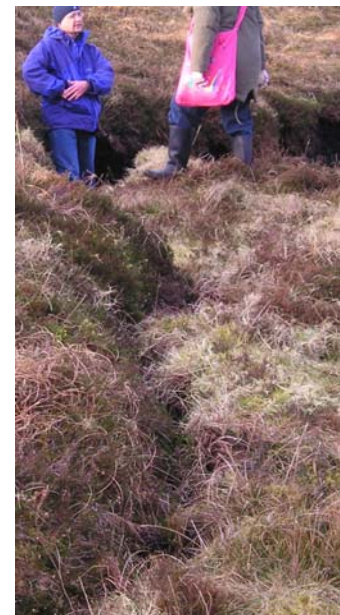
Figure 4. (a) Detail of failures on upper and middle slopes exposing smooth weathered rock surface; (b) detail of shrinkage crack in peat surface in undisturbed area adjacent to slide.

The dry conditions in the summer prior to the slide would have resulted in drying and shrinkage of the blanket peat (Figure 4b). This caused new cracking, reactivation of old cracks and opening of peat fuel cuttings. These cracks were observed by local people in the area before the event and in undisturbed areas adjacent to the slides afterwards. Any increase in stability due to lowering of the water table is likely to have been offset by the reduction in unit weight of the peat by drying. This matter will be addressed in the stability analyses below.

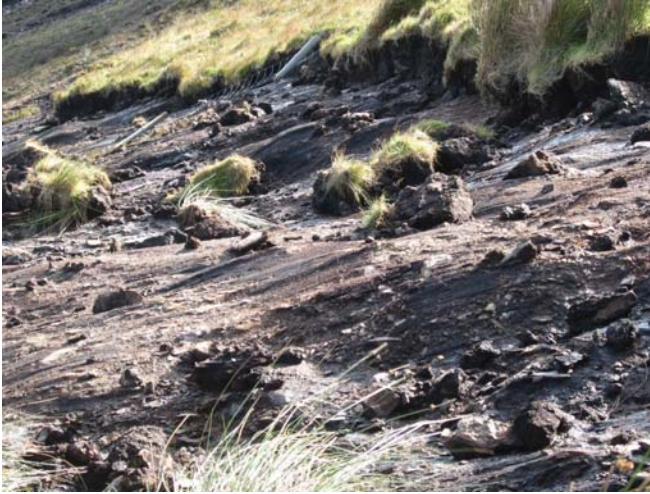
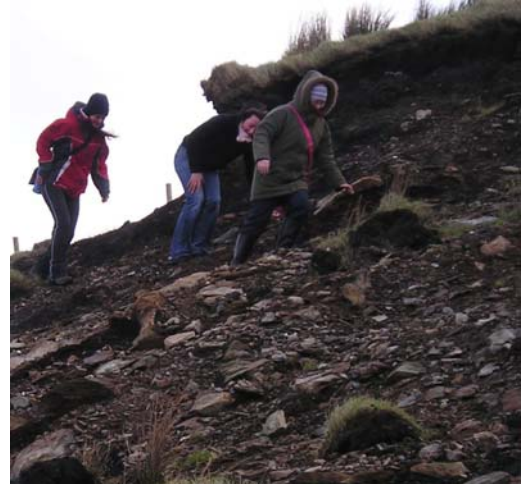
Figure 5. Type A slide slip surface (a) just after slide showing smooth surface in weathered rock and downslope striations and (b) approximately 18 months later where water flow has cleaned surface and locally exposed intact bedrock

The majority of the failures were of Type A and, from observations of the head and side scars were located in the mineral soil above the “hard pan”, see Figure 5(a). This surface was extremely smooth and difficult to walk on. It exhibited striations or scratches in the down slope direction. Some orange colour staining of poorly developed “hard pan” can be observed below the failure surface. Within the weathered rock the failure surface was typically at about 200 mm depth and resembled weathered joints or discontinuities in a rock mass due to its “rusty” appearance and the presence of a seepage zone. Subsequent water flow may have locally exposed the surface of the intact bedrock, Figure 5(b).

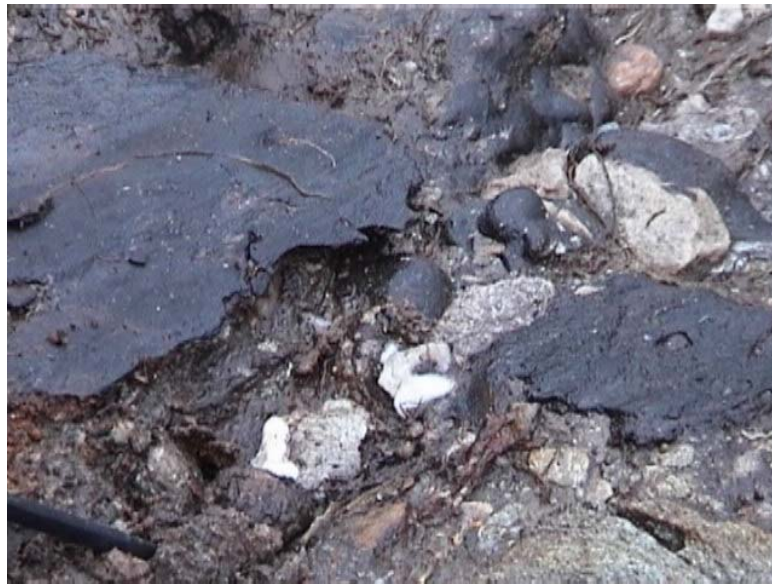
Figure 6. Slip surface in Type B slides: failure plane comprises a thin polished layer (typically 3 to 5 mm) of stiff black to dark brown amorphous silt/clay located near the base of the peat. This layer overlies weathered rock with local nodular "hard pan".

(somewhat to moderately humified) according to the Von Post scale (Hobbs, 1986) Fibres are readily identifiable, are a mixture of coarse and fine, and occur at random orientation. Close to the peat / weathered rock interface, and generally located 200 mm to 300 mm below the top of the weathered rock, there is a layer of “hard pan”. As will be described below, this layer was observed just below some of the failures. This is considered to be a precipitated layer, of iron mainly, but also of manganese minerals, leached from the overlying deposits. Its thickness ranges from a few millimetres to 100 mm and comprises nodular black amorphous silt / clay which is cemented to angular gravel or cobble sized fragments, see Figure 6. Its state was not always as well developed as shown on Figure 6 and sometimes only an orange colour staining was visible in the weathered rock. An important characteristic of this layer is its low permeability and its resistance to root growth. Above the hard pan is a layer of irregular thickness typically 50 to +100mm, but can be absent, of soft to very soft brown to dark brown slightly sandy silt/clay. The top of the zone comprises a thin layer (typically 3 to 5 mm) of stiff black to dark brown amorphous silt/clay (referred to as dopplerite by Feehan and O’Donovan, 1996). The thin layer is polished on the upper surface, which may represent slickensides, see Figure 6.

Of the 50 individual failures, it is estimated that in about 11 of these the failure surface was located in the peat. These failures were of Type B, i.e. shallow rotational slides triggered by mobile sliding material. The failure plane comprises a thin polished layer (typically 3 to 5 mm) of stiff black to dark brown amorphous silt/clay located near the base of the peat, see Figure 6.

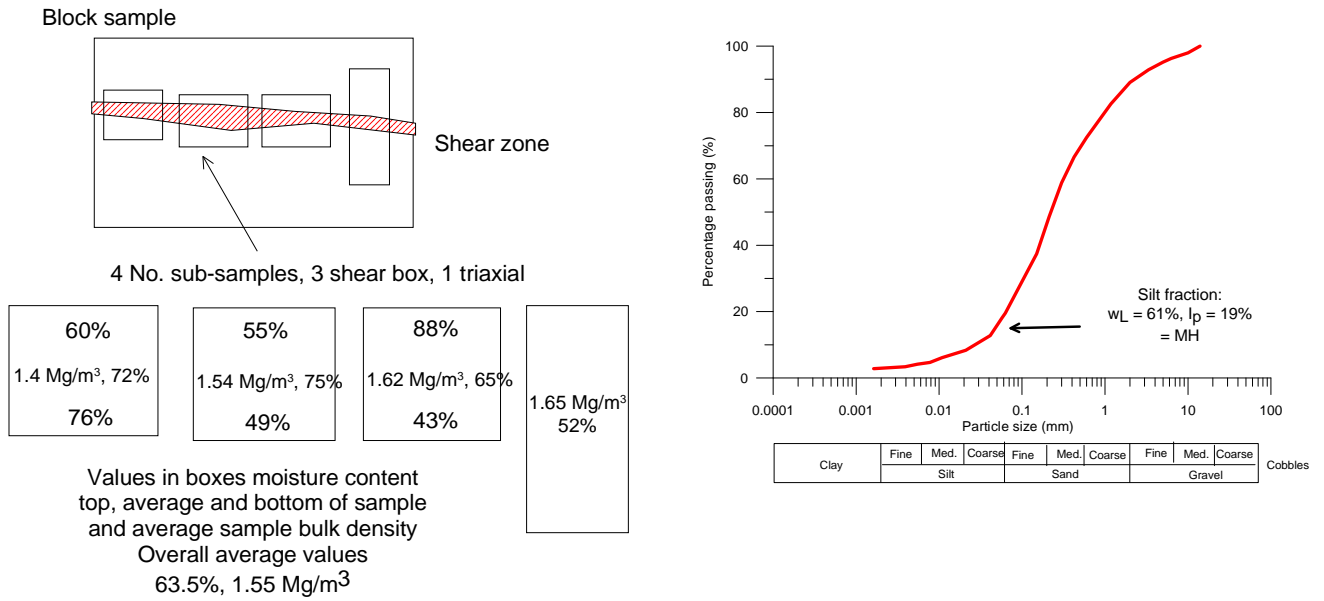
Figure 13. Basic index properties of weathered rock in failure zone.

A block sample of the weathered rock, from the failure zone of a typical Type A slide on Dooncarton Mountain, was sub-divided into four portions for shear box and triaxial testing as shown on Figure 13. A grading curve for the material is also shown in Figure 13. In engineering terms the material can be described as medium dense dark brown peaty sand. Basic index properties are very variable with no obvious correlation to the zone of most intense shearing. Moisture content varies between 43% and 88% with an average of 63.5%. Similarly bulk density varies between 1.4 Mg/m^3 and 1.65 Mg/m^3 with an average of 1.55 Mg/m^3 .

These relatively high moisture content and low density values are suggestive of some leaching and washing out of the material and mixing with peat. This leaching process was studied by O'Dubháin (1978) for similar soils in the east of Ireland. The upper, less humified, peat is the main source of the acid leaching which combines with iron and aluminium in the upper zones of the weathered rock. These organo-mineral complexes are then leached lower into the material where they accumulate to give the organic character to these horizons, as noted above.

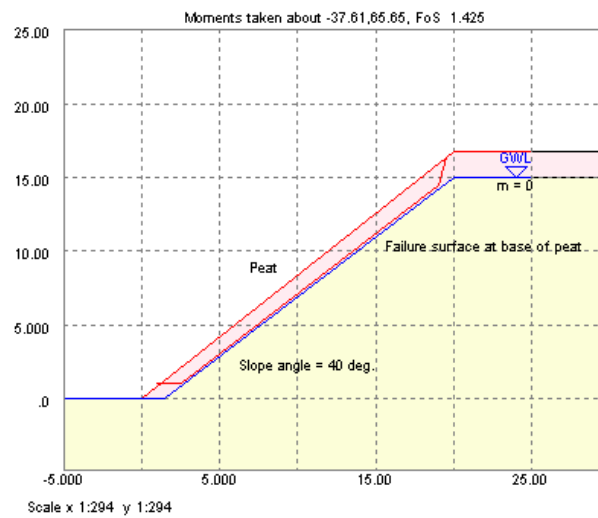
Figure 16. Output from OASYS-SLOPE. (Slope angle 40°, peat thickness 1.2 m, water at base of peat, failure surface near base of peat)

In order to calibrate the relatively simple infinite slope analysis, some calculations were carried out using the method of slices by means of the software OASYS SLOPE, see Figure 16. The example shown is for a 40° slope with 1.2 m thickness of peat and with the failure surface located within the base of the peat. For this example groundwater is assumed to be at the base of the peat. As can be seen the failed mass was subdivided into 10 slices and the factor of safety was calculated using Janbu's method of variably inclined inter-slice forces (Janbu 1957). A factor of safety (FoS) of 1.43 was calculated. For the same conditions, except with a failure surface located in the weathered rock, the factor of safety was calculated to be 0.87, i.e. tendency is for failure to occur in weathered rock on steep slopes, as was observed in practice.

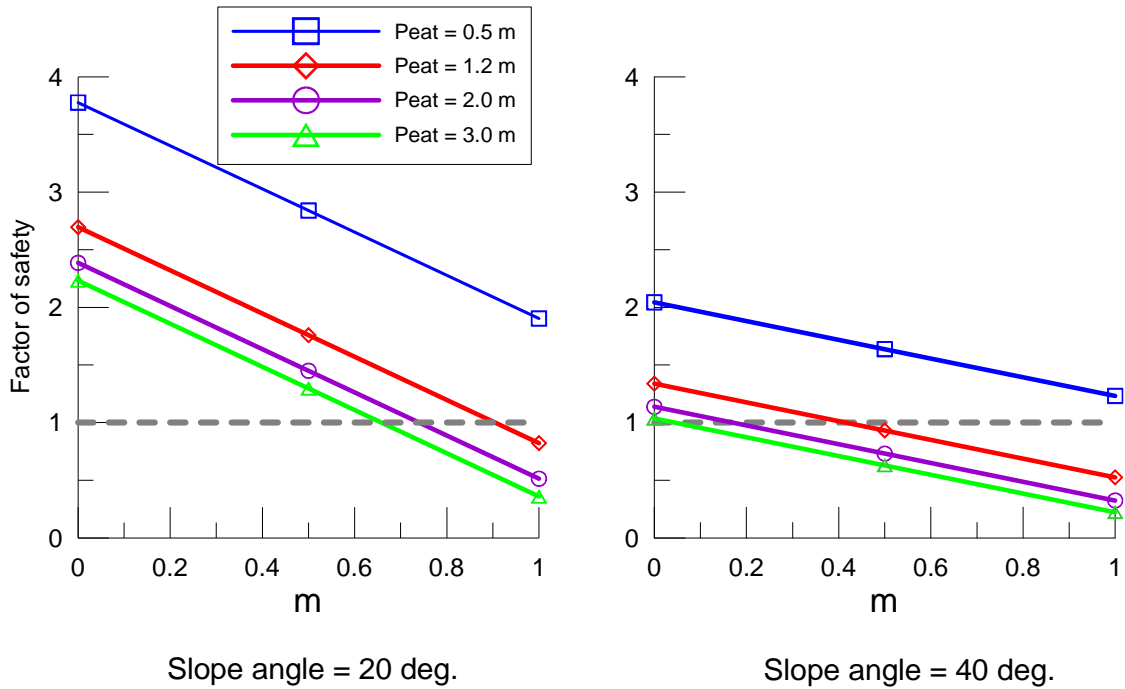
Figure 17. Infinite slope analysis – failure in peat. m is depth of water measured upwards from failure surface

Some output for infinite slope analyses with various peat thickness and depth to the water table and with the failure surface located in the peat are shown on Figures 17. Water pressures in the weathered rock correspond to those at the base of the peat. Slope angles were assumed to equal 20° and 40°, which were in the range of those typically observed in the field. It can be seen that:

- Thin layers of peat can be stable on steep slopes.
- For peat thickness of 1.2 m or greater and high m values, the slope becomes unstable.
- FoS decreases with increasing layer thickness.
- FoS decreases with increasing slope angle.
- Increasing water pressure (m) causes significant reduction in FoS.
- For $m = 0$, peat thickness = 1.2 m and slope angle = 40°, FoS = 1.34. This compares to 1.43 from the more sophisticated method of slices.

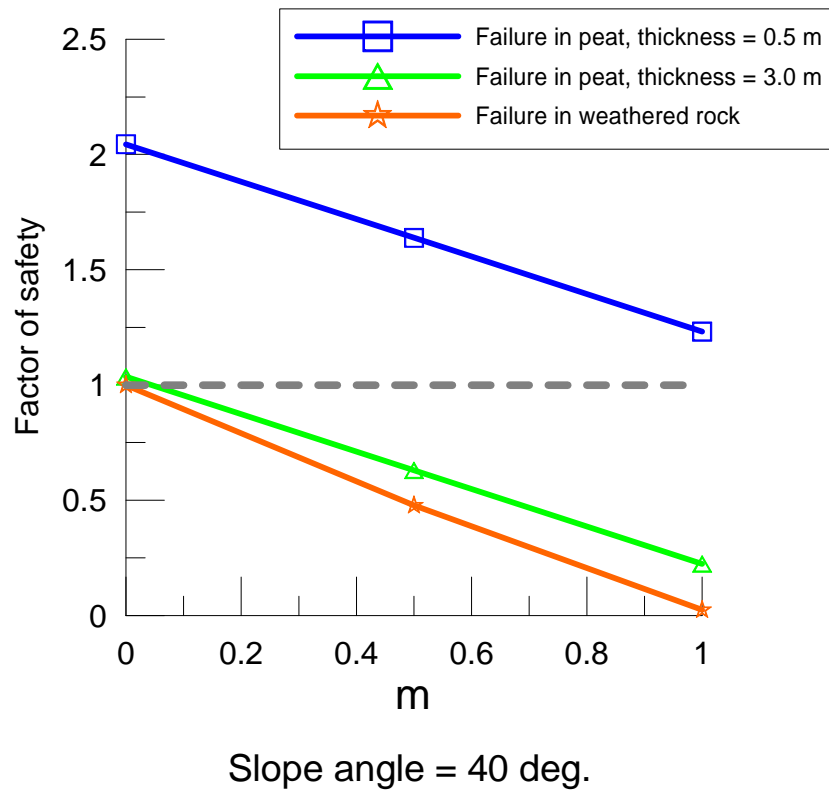
Figure 18. Infinite slope analysis – comparison of failure in peat and weathered rock

Similar output is shown on Figure 18, except in this case a comparison is made between failure in the weathered rock and in the peat for the case of a 40° slope. In this case it can be seen that:

- There is a greater potential for failure in the weathered rock except where the peat becomes thick.

- For $m = 0$, and failure in weathered rock, $FoS = 1.00$. This compares to 0.87 from the more sophisticated method of slices.

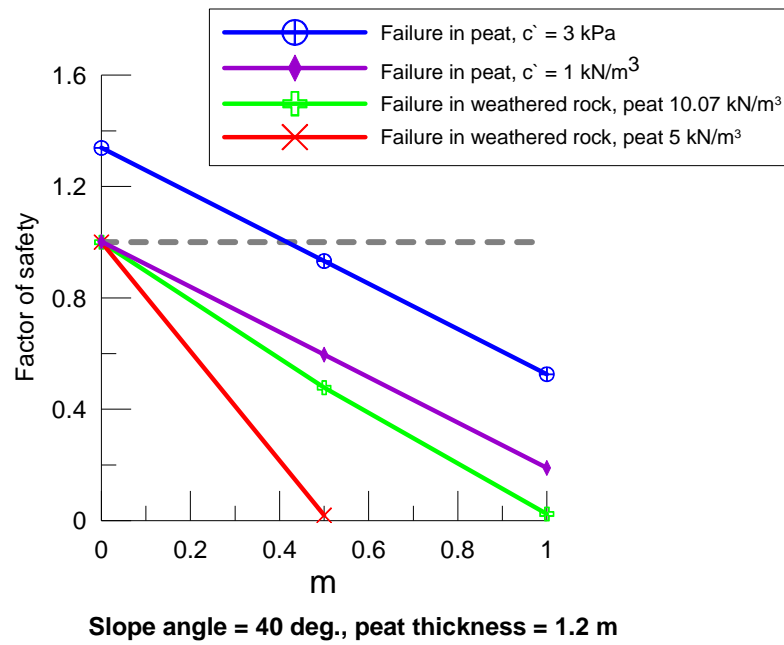
Figure 19. Infinite slope analysis – sensitivity to input parameters of peat
