Slope Instability in Ireland with Particular Reference to Peat Failures

Dr Paul Jennings

Applied Ground Engineering Consultants Ltd., Bagenalstown, Carlow, Co. Carlow, Ireland: pjennings@agec.ie

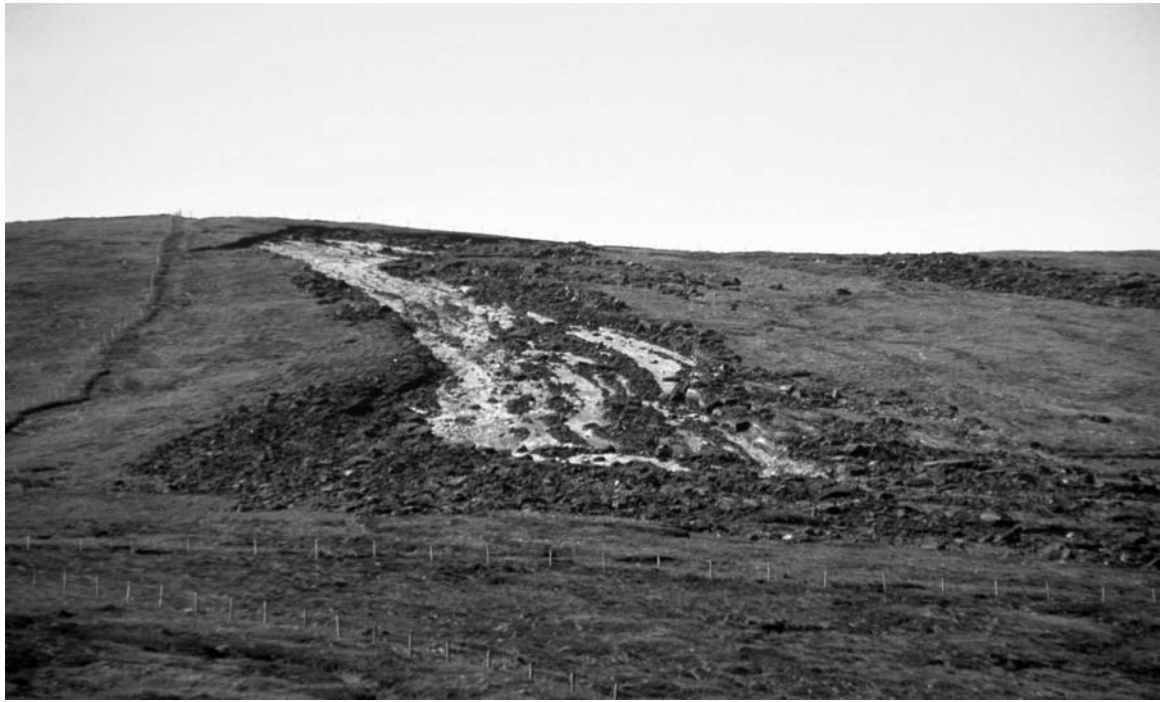
Plate 1 Debris Trial

Comment: Most of the debris has evacuated from the debris trail which seen as a light coloured surface in the view. The peat failed at the interface of the peat and underlying mineral soil, and the light coloured surface is the exposed mineral soil.

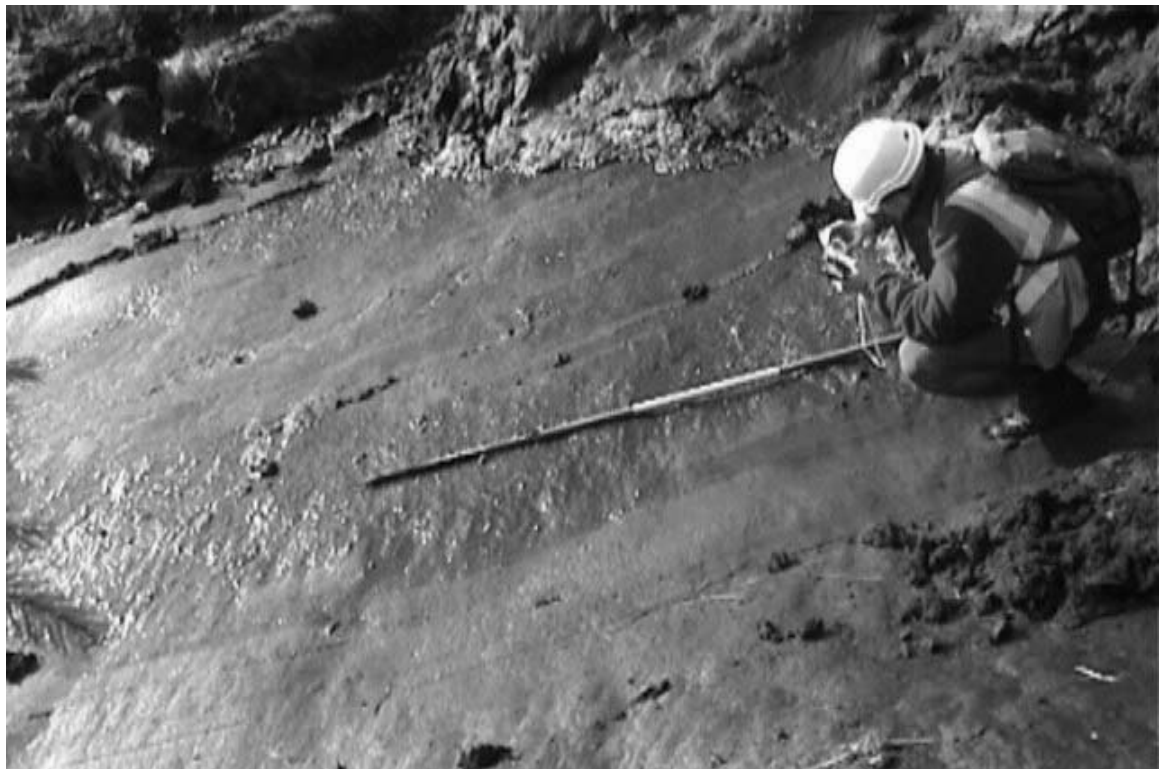
Plate 2 Basal Shear Surface

Comment: Basal shear surface comprises peat. The shear surface is located about 300mm above the base of the peat deposit. In this example some 2 to 3m of peat overlay the shear surface and failed as a translational slide moving to the left of the view.

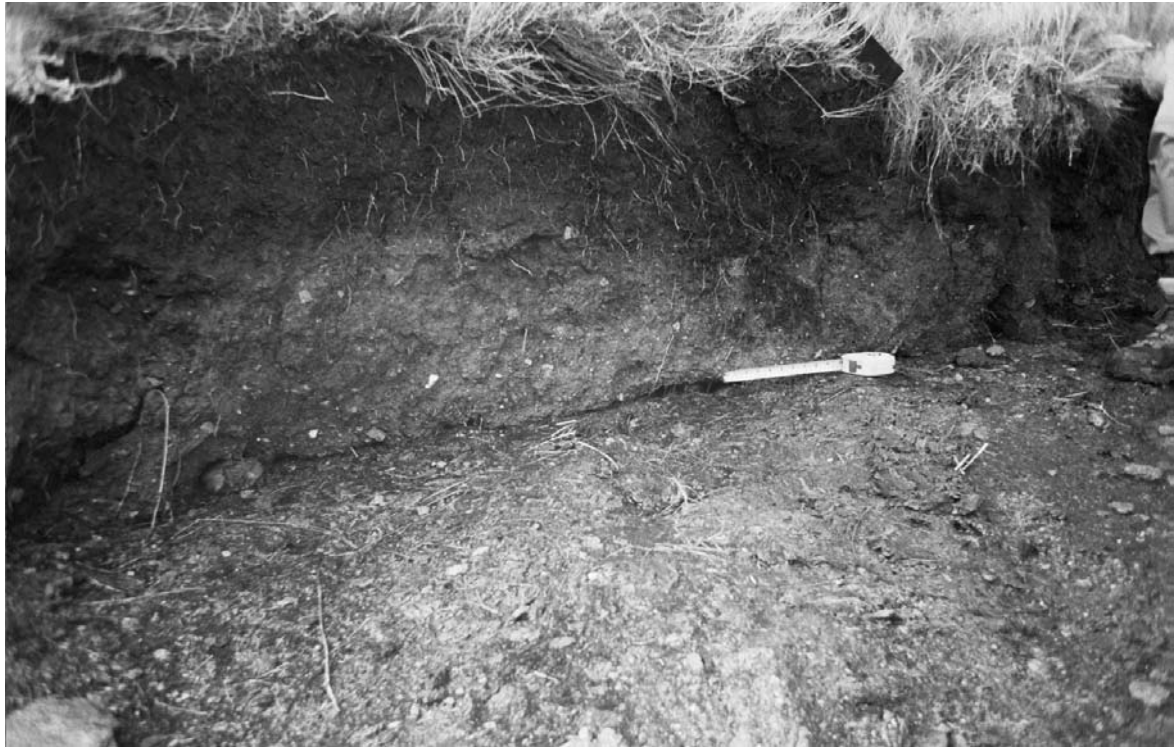
Plate 3 Emergent Shear Surface

Comment: This is a view looking into the head of a failure where a discrete surface is visible (marked by tape measure in view) emerging from the apparently stable ground behind. In this example the failure surface is within mineral soil below the peat. The failure involved less than about 1m thickness of soil.

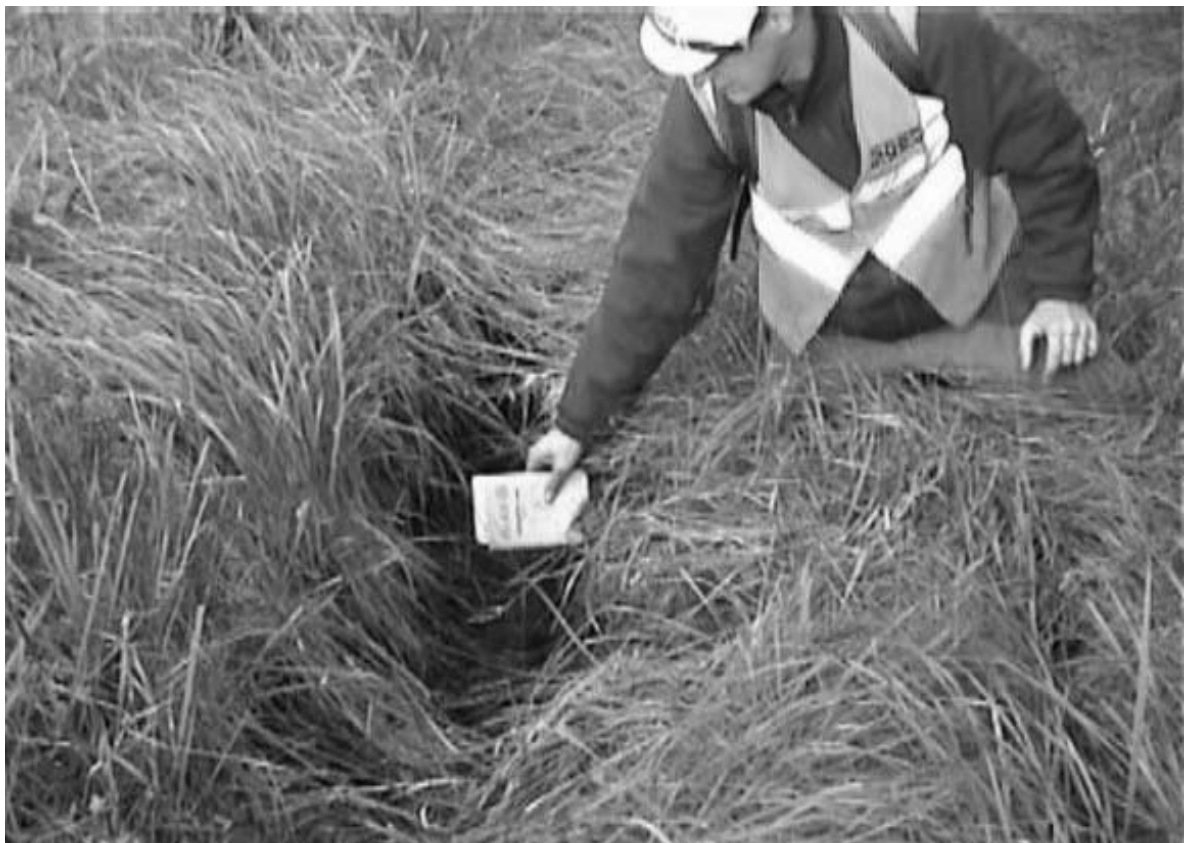
Plate 4 Tension Crack

Comment: This tension crack was one of many found around the periphery of a recent peat failure. Tension cracks provide an indication of the likely extent of distressed ground beyond the failure.

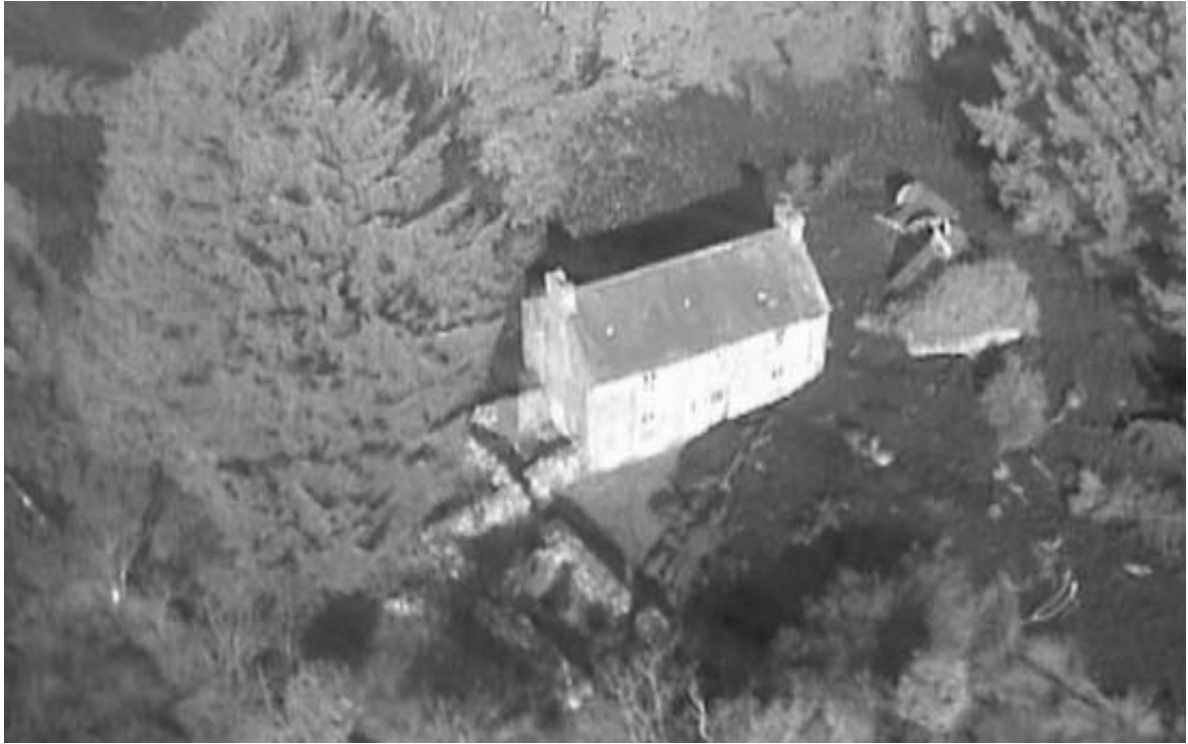
Plate 5 Debris Deposition

Comment: Peat debris from the failure at Derrybrien, County Galway travelled several kilometres before coming to rest. The view shows peat debris, shown as dark brown which flowed from left to right, depositing on level ground around a long-since disused dwelling. The peat debris has travelled nearly 2 km at this point.

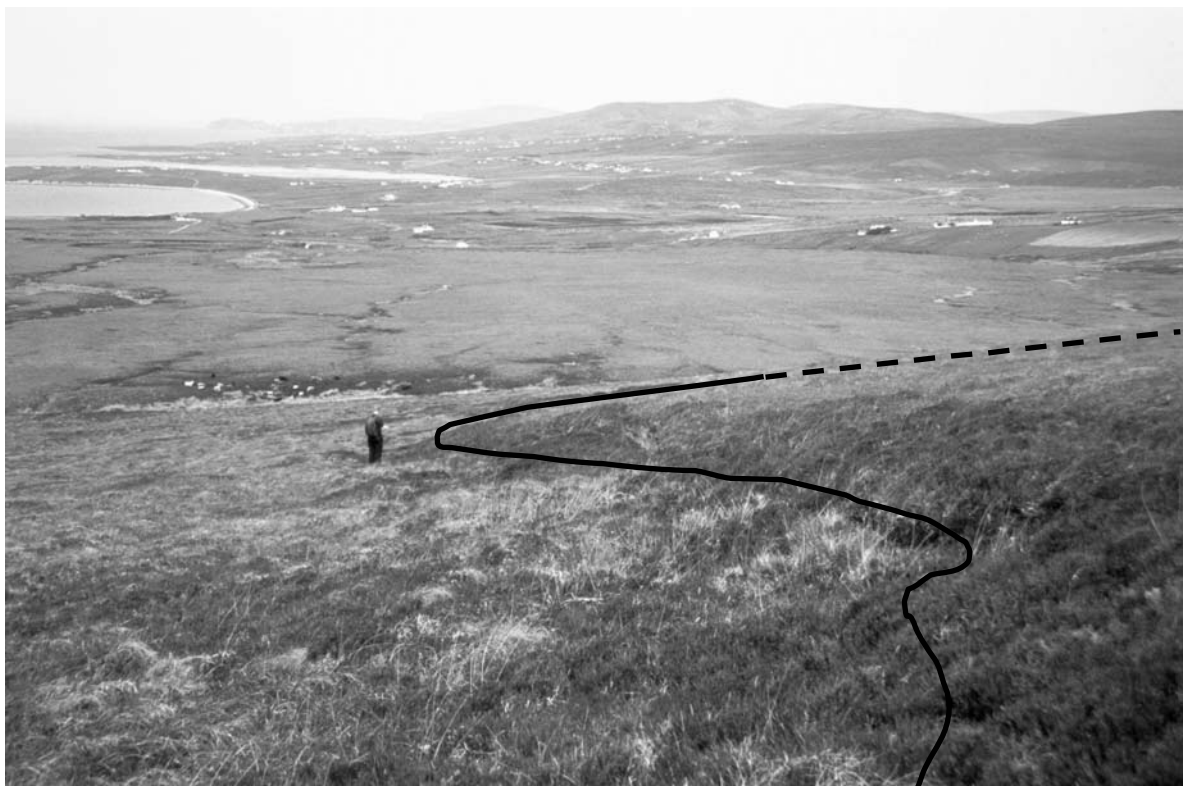
Plate 6 Glencastle Hill Failure

Comment: Failure occurred in 1867 and involved the failure of peat over an estimated 16 ha. The view demonstrates the difficulty in identifying old failures; all the ground to the left of the black line has failed. The black line is co-incident with a 1.5m high step on the slope, which marks the head of the failure.

Photographs showing peat failure scars are given in Plates 6 to 9. Some of the older scars, such as the Glencastle Hill Failure of 1867 (Plate 6) can be difficult to identify with the main indicator of a previous failure being a sharp 1m to 2m step in the slope profile marking the head of the failure. The recent failure on Mount Lenister (Plate 9) occurred on a peat covered slope, however closer examination of the scar showed only a thin peat cover with the basal failure surface located in the underlying mineral soil.

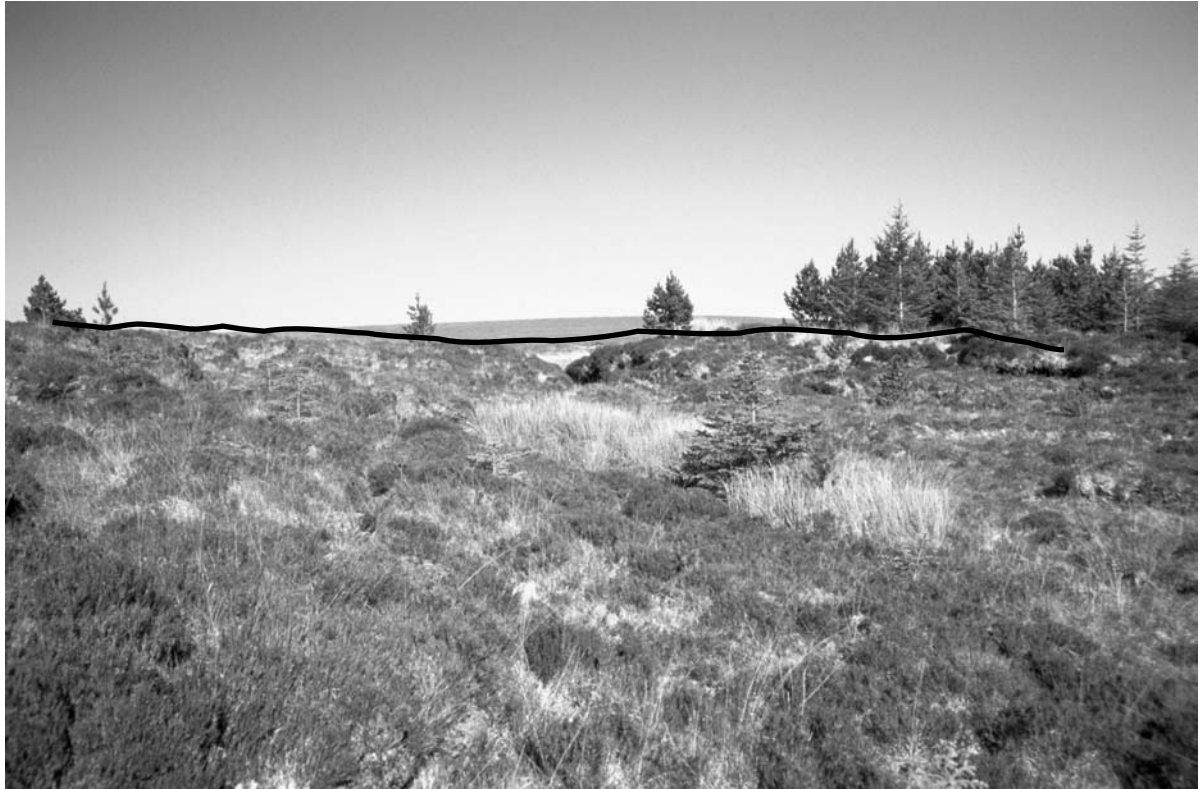
Plate 7 Boleynagee Lough Failure

Comment: Failure occurred in 1931 and was described as a bog burst. The view is looking from inside the failure scar upslope to the head of the failure, as marked by the black line.

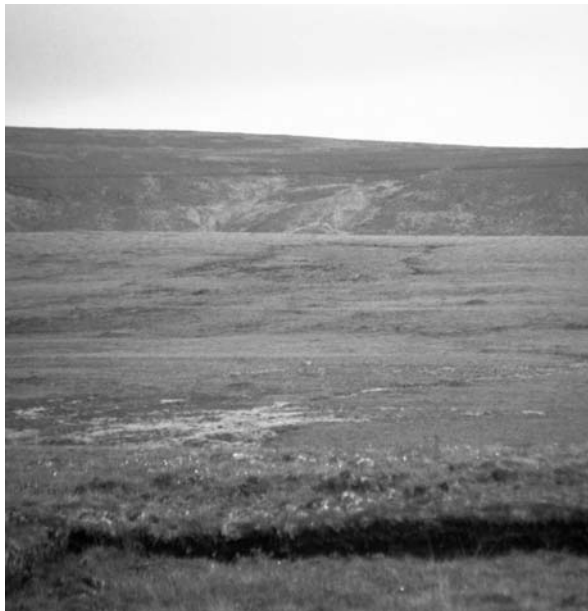
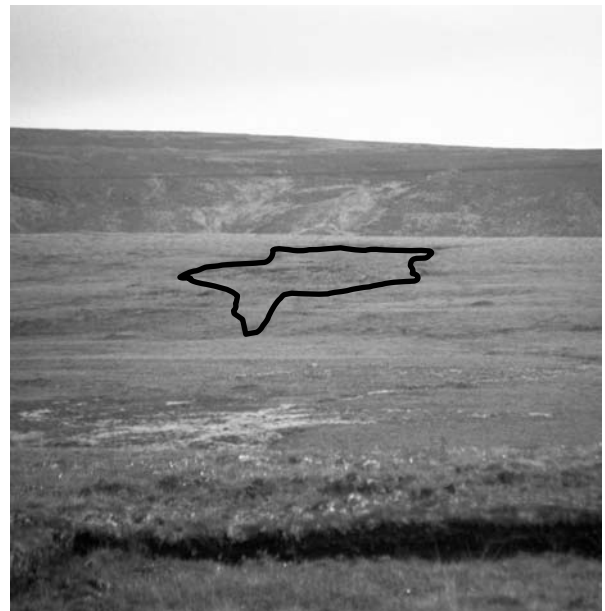
Plate 8 Glenamoy Failure.

Comment: Failure year unknown but assumed in past few decades. The failure volume is estimated at $14,000\text{m}^3$. Both views above are the same showing a long-distance look at the failure scar. This highlights the difficulties in observing some failure scars in the landscape. The view on the right has the scar highlighted.

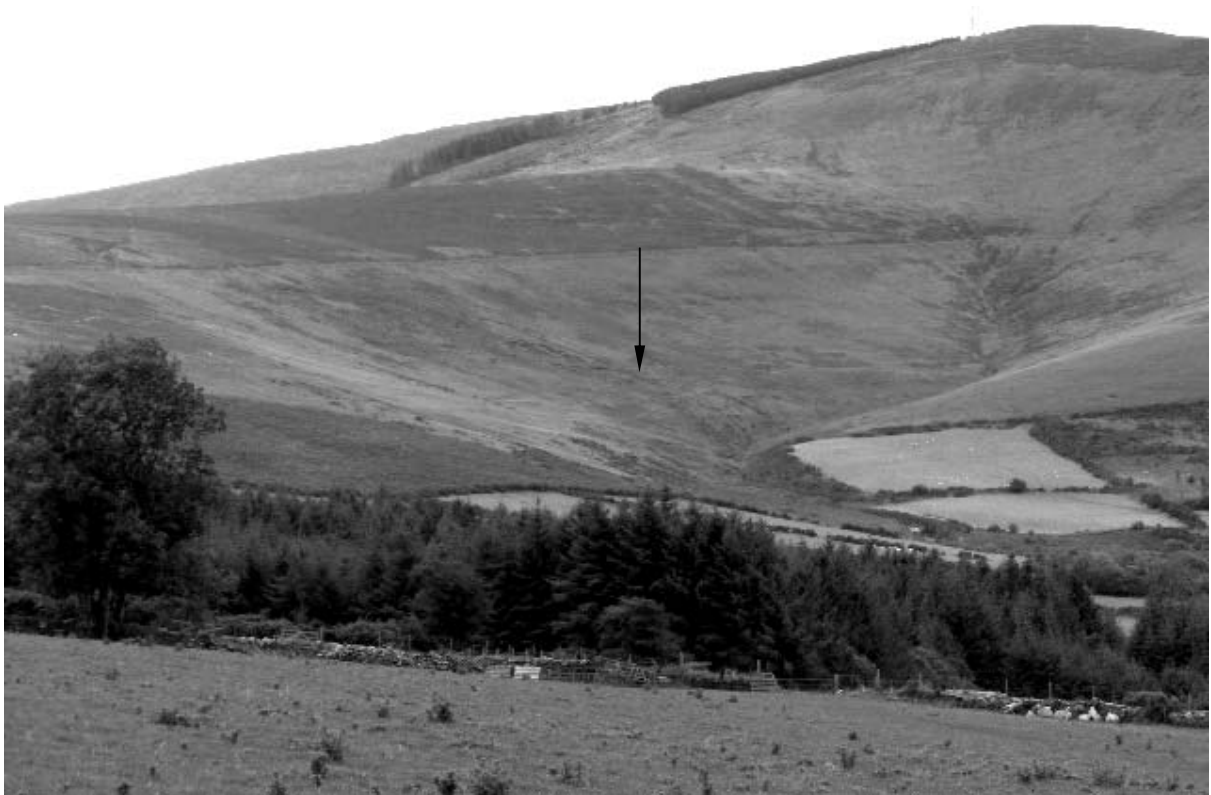
Plate 9 Mount Leinster

Comment: Failure occurred in 2004. Though the slope is peat-covered, closer examination of failure (arrowed in view) showed that the basal failure surface was within mineral soil. Peat thickness was typically less than 0.5m and appeared in many cases to comprise essentially an organic mineral soil.
