# Peat slope failures and other mass movements in western Ireland, August 2008

A.P. Dykes<sup>1,\*</sup> & P. Jennings<sup>2</sup>

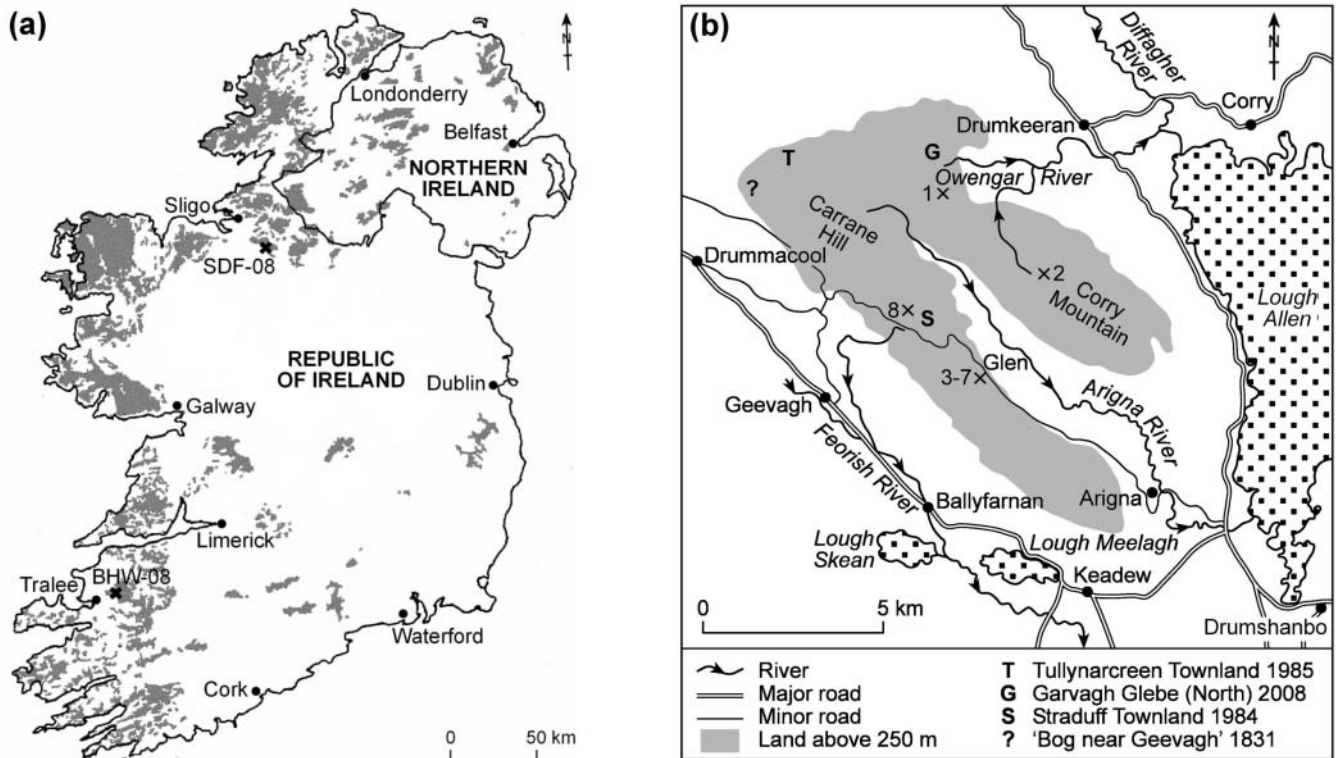
**Fig. 1.** (a) Distribution of blanket peat in Ireland, indicating locations of the landslides (after Tallis 1998). (b) Locations of the Corry Mountain–Carrane Hill landslides (identified by  $\times$  and labelled as Numbers 1–8) and other peat landslides in this area. Landslide 8 is bogflow SDF-08 in (a).
